CPA Funding – FY2020 Final Application

Arlington Housing Authority
Building Envelope Repairs, Window Replacement, Phase 1
Winslow Towers 667-3, Elderly Housing
Schematic Report and Recommendations

Re: Winslow Towers Condition Assessment - DRAFT
WJE No. 2017.6855

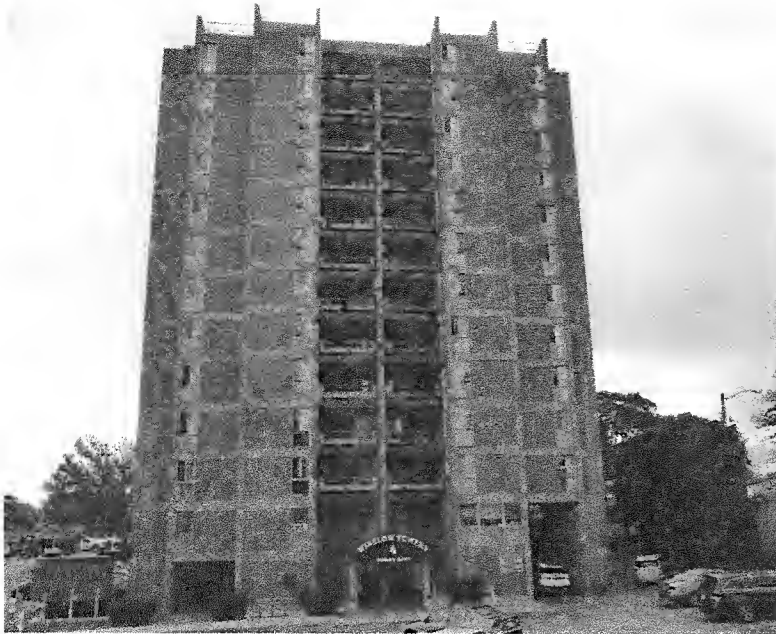
Figure 1. Winslow Towers, west facade

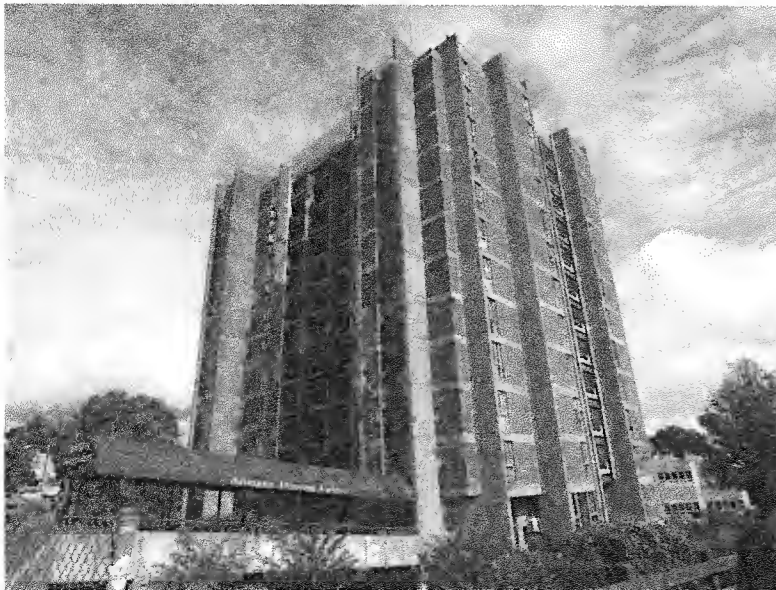
Figure 2. Southeast corner with pedestrian bridge at the south facade

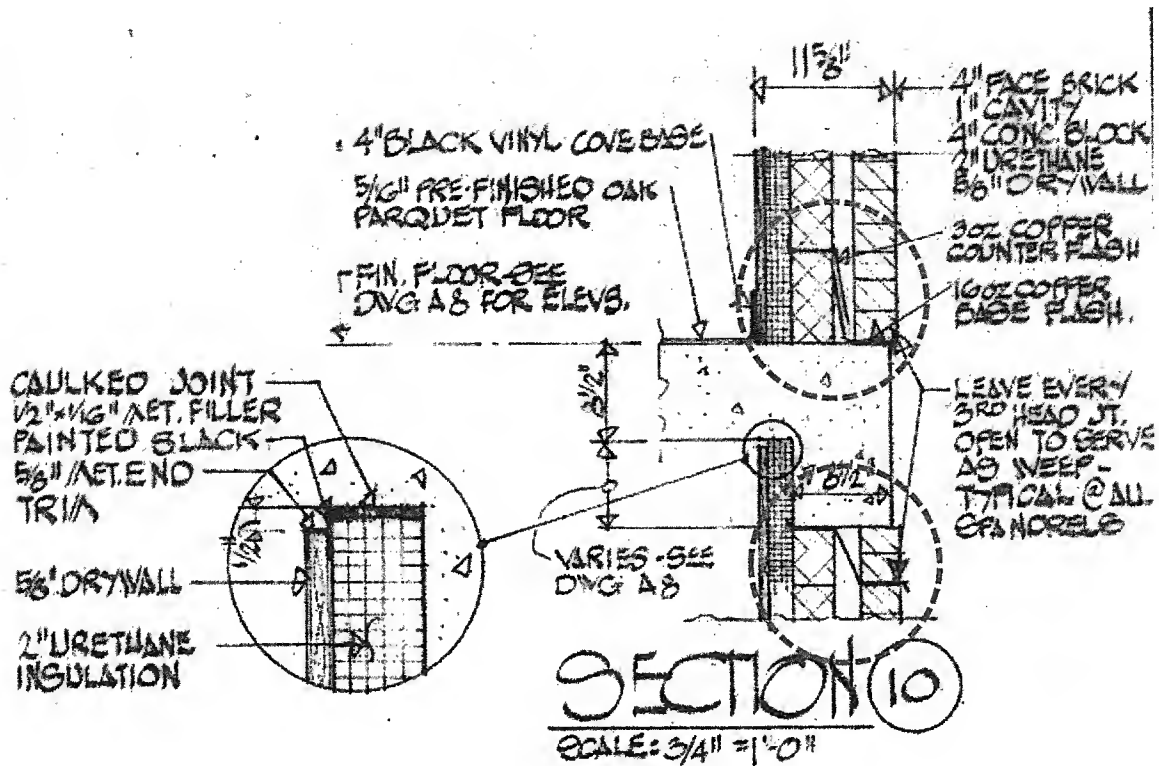
- Typical cavity wall construction spans between floor slab and perimeter beam soffit, and includes face brick, a 1-inch wide cavity, 4-inch thick concrete masonry block (CMU), 2-inches of rigid insulation, and 5/8-inch thick gypsum wallboard' (Figure 3 and Figure 4).

Figure 3. Typical section detail at floor line and concrete perimeter beam soffit from original construction documents, prepared by Robert Charles Associates, Inc., dated December 11, 1967. Note locations of through wall flashings (circled).

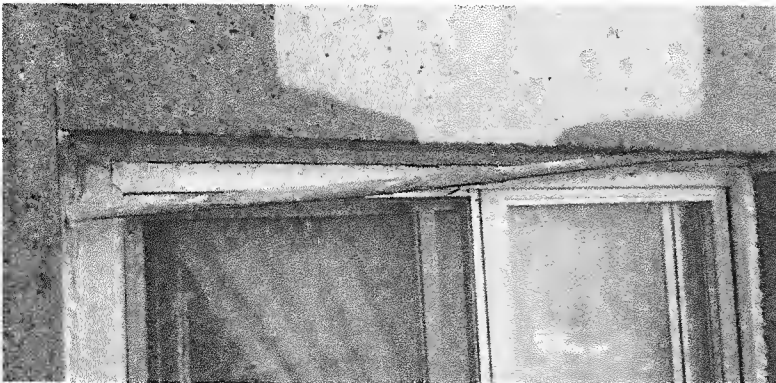
- There is a crack along the second floor soffit at the east facade. There is also efflorescence along the crack (Figure 21).
- There are several holes and unsealed penetrations at the facades, in particular at the first floor (Figure 22, Figure 23).
- At multiple locations, there are displaced pieces of wood that appear to have been used originally to form the drip edge above the window and were never removed (Figure 24).

Figure 24. Displaced wood coming from drip edge above window at west facade

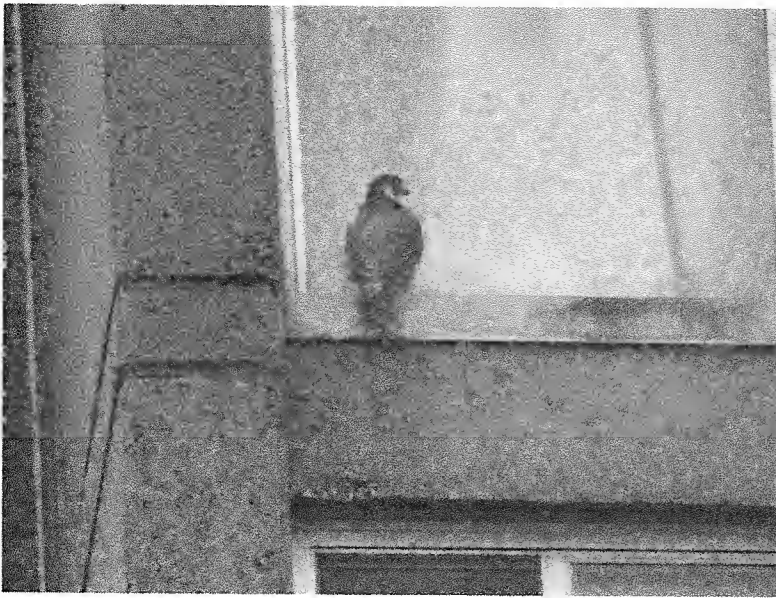
- A peregrine falcon was spotted at the west facade during the binocular survey performed by WJE (Figure 52).

Figure 52. Peregrine falcon perched on west facade

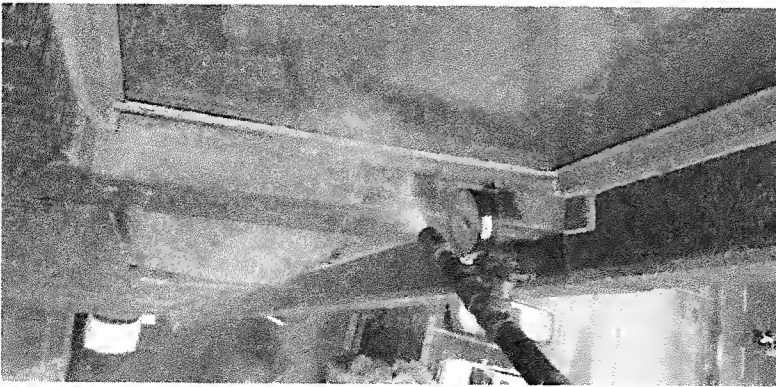
Diagnostic handheld spray nozzle testing began with the first test at the west facade bedroom window of Unit 1102. The window directly below in Unit 1002 was covered with plastic to direct water away from this window assembly. The testing was focused initially on the window sill, window sill sealant, and sill flashing (Figure 53 and Figure 54). The building water pressure fluctuated throughout the testing, test pressure was controlled using the valve to keep pressure as close to 20 psi as possible. Testing was performed by spraying water along the window sill, moving the nozzle at a speed of 1 linear foot (LF) per minute. The total test time was approximately 20 minutes. No water infiltration was observed during this test.

Figure 53. Testing with spray nozzle at window, west facade, eleventh floor

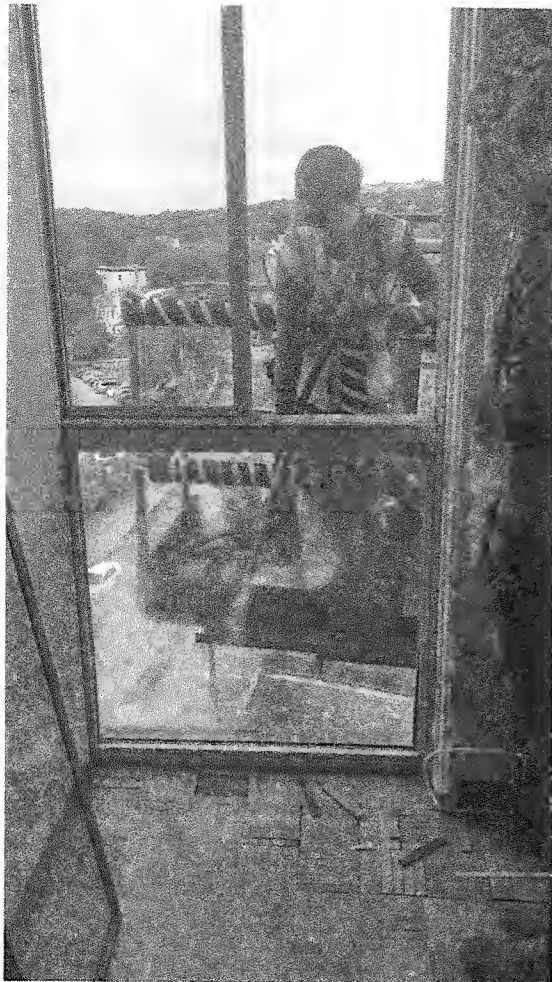
Figure 54. Testing with spray nozzle at window, west facade, eleventh floor

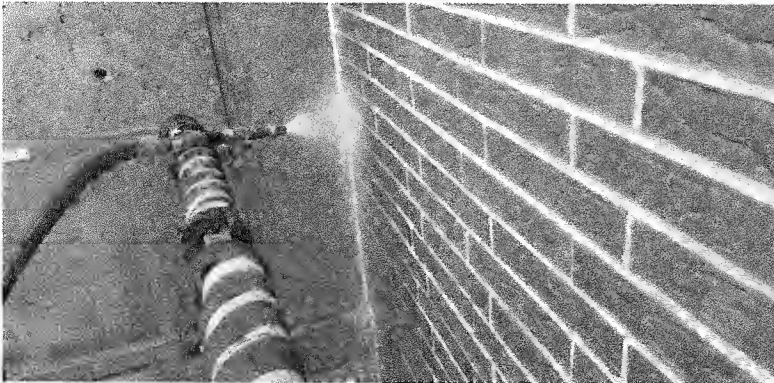
Testing was subsequently performed at the vertical sealant joint along the interface between the concrete wall and the masonry infill wall at the building corner. The third test started at this vertical corner sealant joint, starting at the soffit of the twelfth-floor concrete perimeter beam (immediately above the eleventh-floor window level). During this test it was reported that there was water infiltration at Unit 902, two floors below. Testing was temporarily stopped. Water infiltration was observed at the ceiling adjacent to the bedroom window in Unit 902 (Figure 58 and Figure 59). Testing restarted at the vertical sealant joint. Testing was performed by spraying water up the vertical sealant joint, moving the nozzle at a speed of 1 LF/minute (Figure 60). After 15 minutes, water was observed at the ceiling, at a concrete crack approximately two feet from the exterior wall (Figure 61). As the test continued, the water infiltration moved further into the interior along the concrete crack (Figure 62). The test was concluded after approximately 30 minutes. Water continued to enter at the ceiling even after the water was shut off.

Figure 60. Water sprayed through spray nozzle at vertical corner sealant joint at eleventh floor

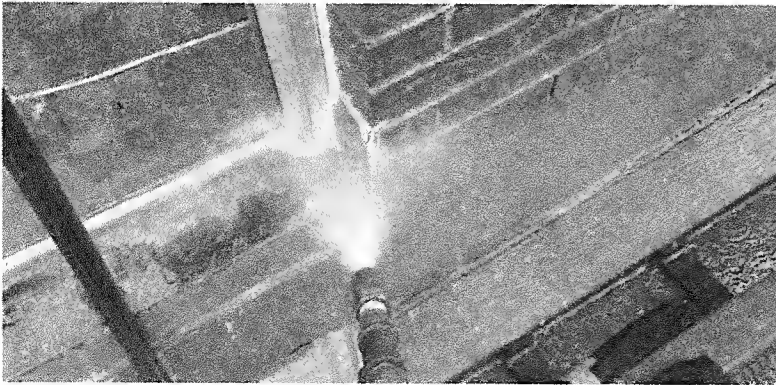
Subsequent testing at the fourth location was at the facade corner at the living room. Initial testing at this location focused on the floor line and the window sill. Testing was performed by spraying water along the floor line at the interface of the concrete perimeter beam and brick infill above, moving the nozzle at a speed of 1 LF/minute towards the window (Figure 63). Testing ended at the window sill flashing when water was observed at the interior at the floor (Figure 64). Parquet flooring was removed to better observe the water infiltration. Water continued to enter below the living room window even after the water was shut off. Voids in the sealant at the window sill were noted during the testing (Figure 65 and Figure 66). Additional testing (Test No. 5 in Table 1) at the concrete perimeter beam flashing (below the beam) in the same area did not result in any additional water infiltration (Figure 67).

Figure 63. Water sprayed through spray nozzle at concrete floor line and brick infill on exterior of living room window of unit 1102

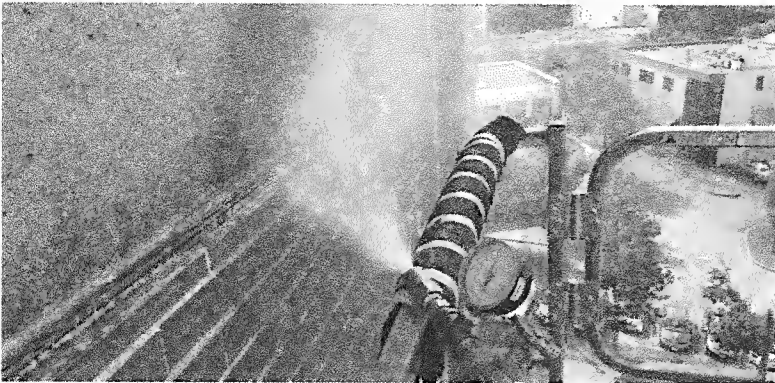
Figure 67. Water sprayed through spray nozzle at concrete perimeter beam soffit flashing on exterior wall outside the living room of unit 1102
